# PROTECTING RHODE ISLAND'S SHORELINES FROM FLOODING AND EROSION

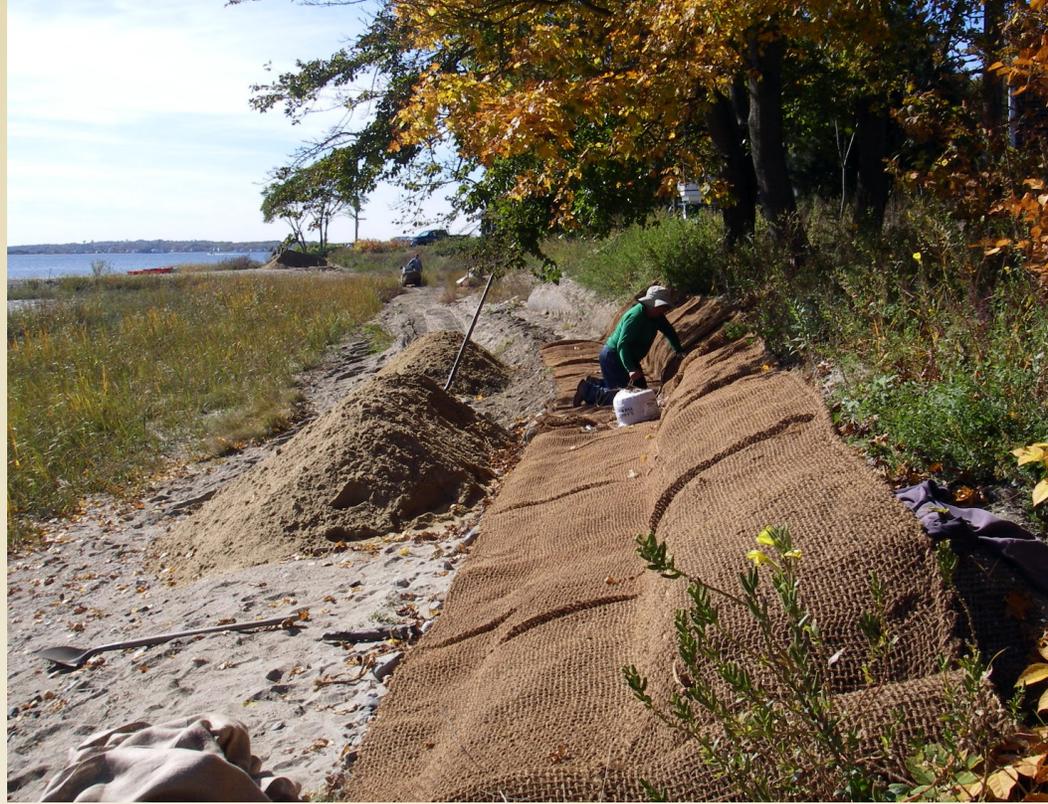
Soft structures made out of biodegradable coconut fiber such as supersized sand bags and coir logs are allowed (with permits) and tend to

dissipate more wave energy than hard structures, reducing erosion. Despite being biodegradable, these measures are actually less expensive to build and maintain than hard structures.

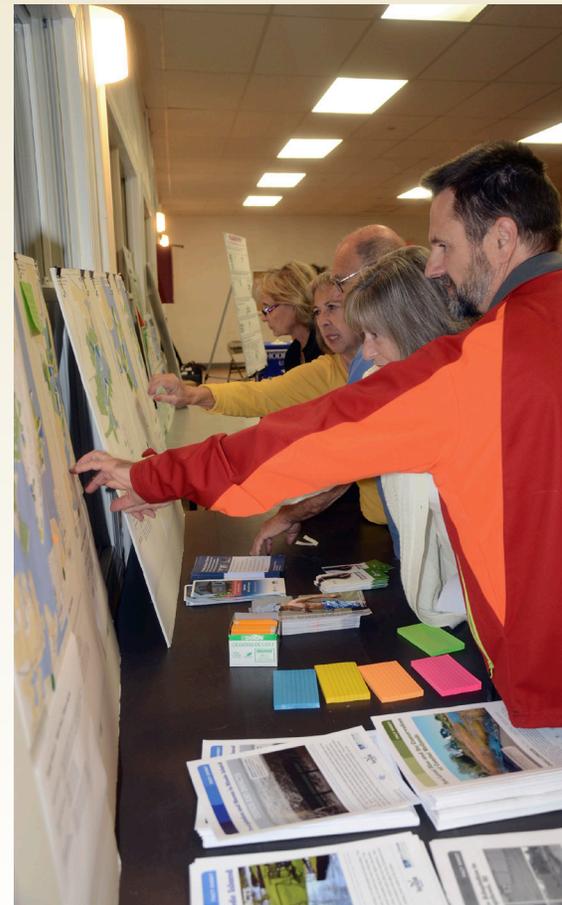
**Above:** A coir structure is used to protect Allins Cove in Barrington. **Below:** North Kingstown residents examine floodplain maps at a community meeting.
